A Case Study in City Design  
and Engineering with  
**INTERLOCKING  
CONCRETE  
PAVEMENTS**

*Renovation of interlocking  
concrete streets and sidewalks  
in North Bay, Ontario.*

This case study describes how concrete pavers were an essential component in unifying the identity of the central business district of North Bay, Ontario. It reviews how pavers were selected, the considerations involved in design and construction, and the results of an engineering evaluation after eight years of service.

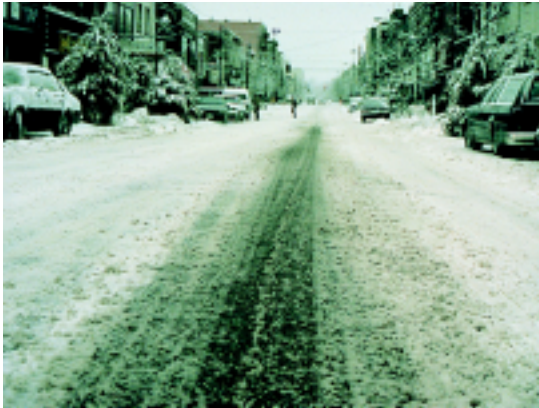
Figure 3. Main Street receives 300 tons of deicing salt each winter, plus sand for traction.

About 105 in. (270 cm) of snow falls each year in North Bay. To keep traffic moving, the City of North Bay removes snow and ice every winter with snowplows, as well as with rock salt and sand. Main Street alone receives 300 tons (270 t) of salt each winter. (Figure 3) Interlocking concrete pavement was given first consideration because it had successfully performed around city hall for five winters under deicing salts. A genuine test of durability would be paving Main Street with concrete pavers crosswalks and ramps with colored units as permanent markings.

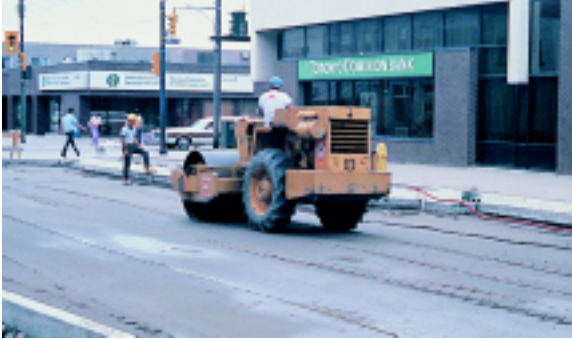
Figure 5. Compaction of the base is essential to all flexible pavements including those built with concrete pavers.

In constructing the streets, the subbase and base were compacted and the density of the base material was checked regularly with a nuclear density gauge (Figures 5 and 6). This helped ensure 100% modified Proctor density. As with any flexible pavement,

monitoring density of the base to achieve a specified level of compaction is critical to the long-term performance of interlocking concrete pavements.

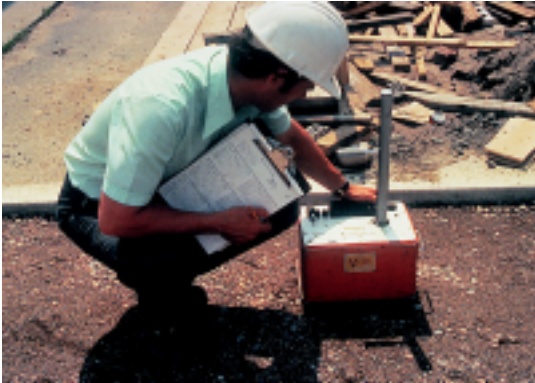
Figure 6. Monitoring of base compaction during construction minimized the likelihood of settlement later.

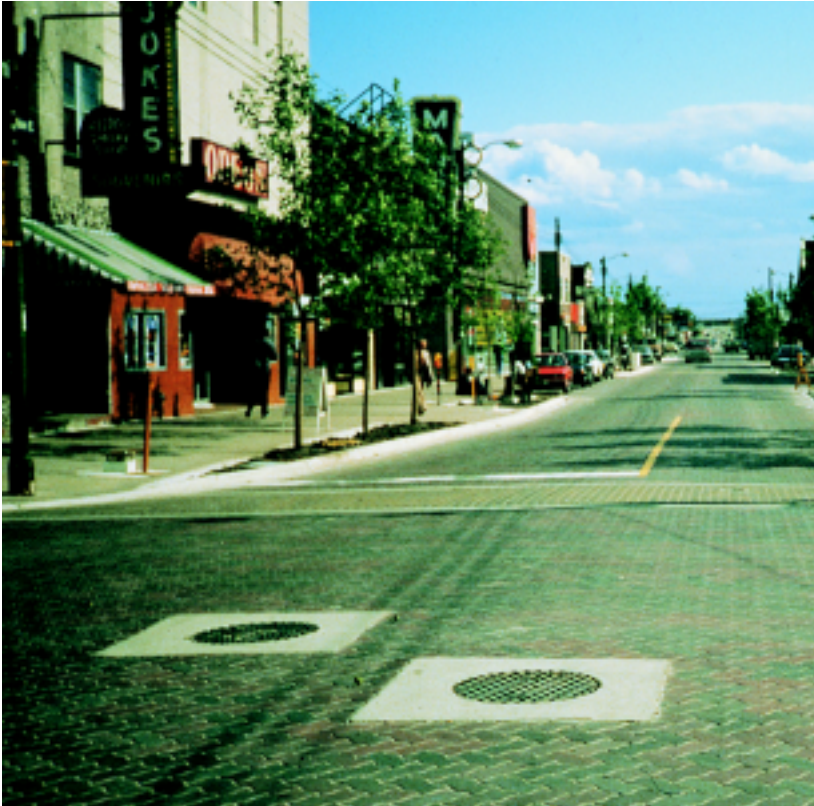
Figure 7. Concrete collars protect utility structures.

All interlocking concrete pavements require edge restraints to prevent lateral creep. For the North Bay project, cast-in-place concrete curbs were used. In addition, the curbs also established grades for the finish elevation of the pavement. Concrete collars were cast around utility structures to secure the iron frames. The collars provided a stationary restraint for the concrete pavers (Figure 7).

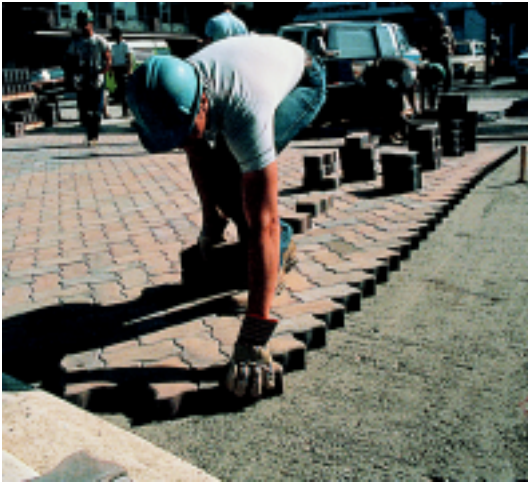
Figure 8. A herringbone pattern in the street provided resistance to turning,

A herringbone pattern in the streets offered the greatest degree of interlock for the pavers (Figure 8). A slight crown in the road for drainage also contributed to interlock, strengthening the pavement as the pavers settled slightly from traffic (Figure 9). After the pavers were placed in a herringbone pattern, they were compacted with a plate compactor. The force of this machine moves bedding sand into the joints between the pavers and begins interlocking of the units (Figure 10). After an area is compacted, sand is swept into the joints and the pavers are compacted again until the joints are completely full of sand (Figure 11). The compacted pavers with sand-filled joints interlock so that vehicular loads are transferred from one paver to the next.

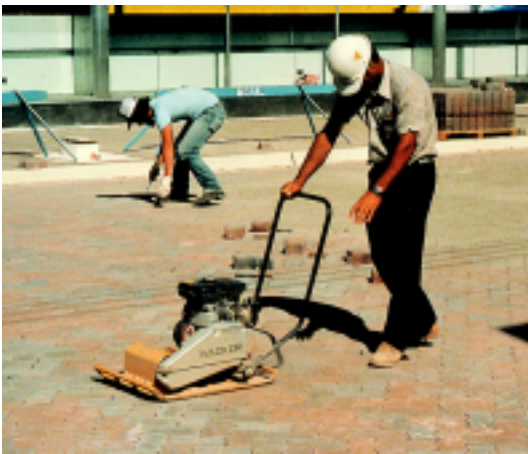
Figure 10. A plate compactor seats the pavers in the bedding sand.

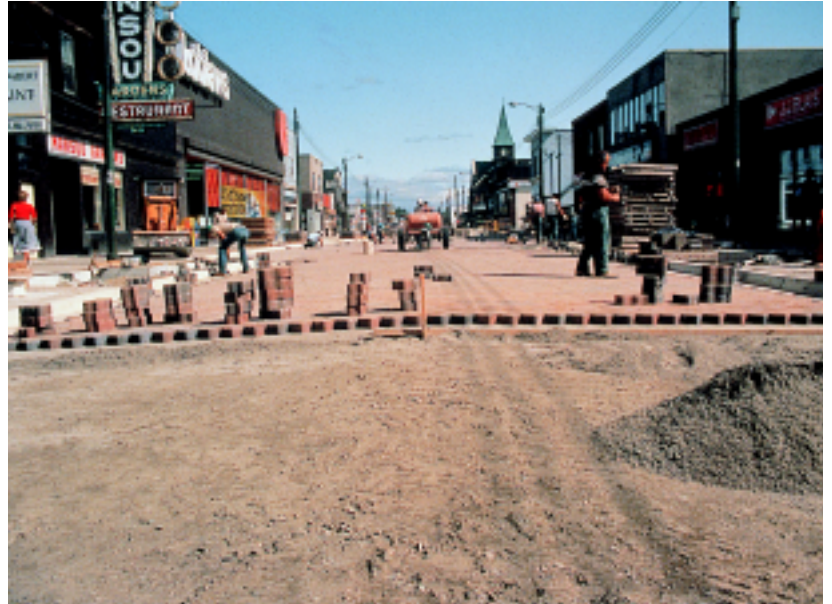
Figure 9. A crown in the road contributes to interlock by allowing the pavers to settle and tighten slightly under traffic.

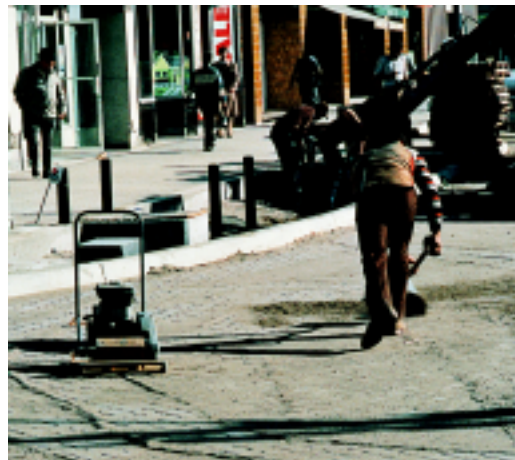
Figure 11. Sand swept into the joints and compaction of the pavers transform the pavement from a loose collection of units to an interlocking load-bearing pavement system.

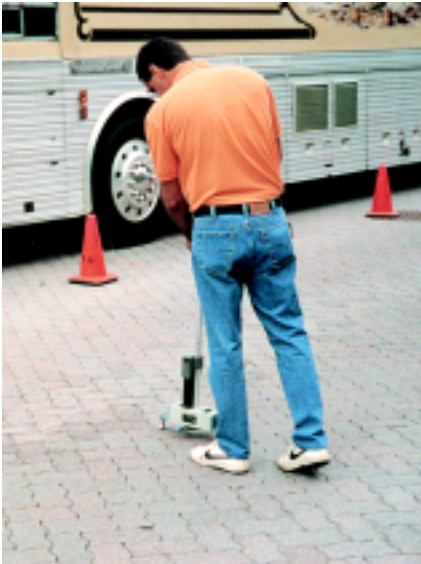
Figure 12. Rut depth measurements after eight years of traffic showed rutting to be slight.

Some 230 measurements of wheel rut depths were taken from the curb to the center-line along Main Street (Figure 12). Average rut depths were 0.22 in. (6 mm), much smaller than the 0.5 to 0.75 in. (13 to 19 mm) depths considered as failure by most highway agencies.

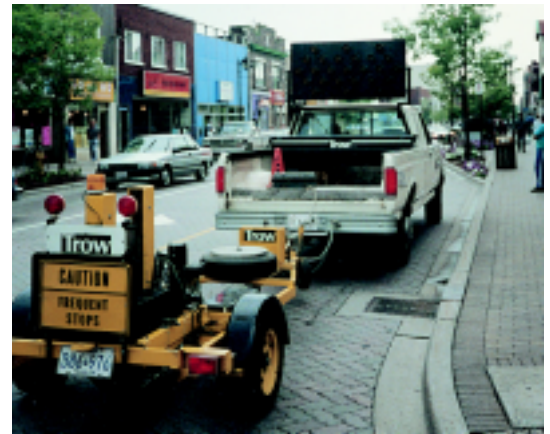
Figure 13. A falling weight deflectometer was used to evaluate the structural capacity and remaining life of the pavement.

Structural evaluation was made with a falling weight deflectometer (FWD), a testing machine that simulates the small but rapid deflections of pavements under moving vehicular loads. A Dynatest FWD mounted on a trailer applied impulse loads of 5,000 to 9,000 pounds (22 to 40 kN) to 242 locations on Main Street (Figure 13).

Pavement layer moduli (a measure of pavement stiffness based on applied stresses and resulting strains from deflection loads) were calculated using a computer program. The program modeled a three-layer structure: a 4.125 in. (105 mm) thick composite of concrete pavers and bedding sand as a single layer, the 14 in. (350 mm) thick crushed aggregate base and subbase, and the soil subgrade. Average pavement layer moduli are shown in Table 2.
